## Problem Solving

### Positive Displacement Pumps

This document has been produced to support pump users at all levels, providing an invaluable reference tool. It includes information on general Positive Displacement pump problems and their effect on rotary lobe pumps with suggestions as to probable causes and solutions.

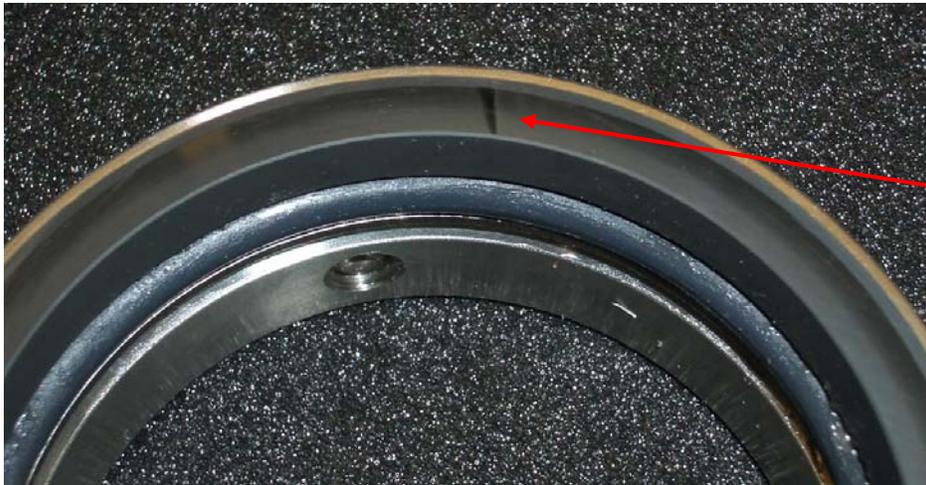
Thermal stress is a common cause of fracture and usually occurs when the seal face is subjected to rapid temperature change i.e. after pumping hot media the pump/seal is cleaned with a cold cleaning fluid.

**Example of crack in seal insert caused by thermal shock**

Replace seals and investigate process and CIP temperature regimes and change accordingly.

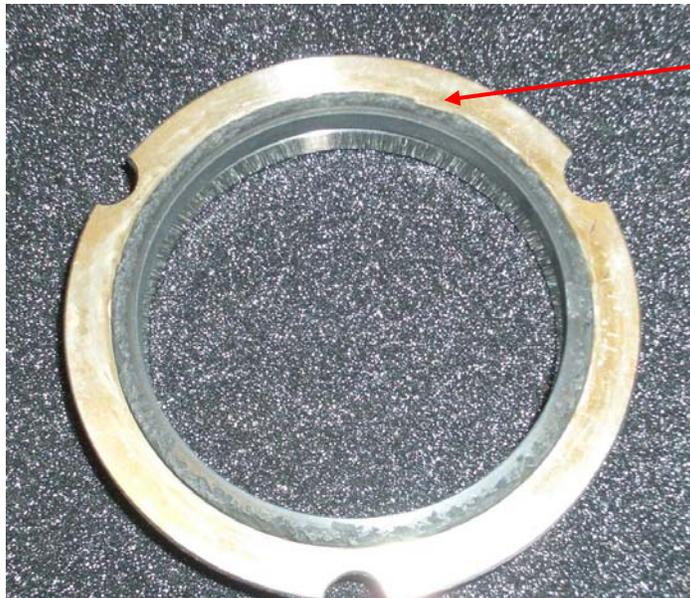
This is evident in soft seal face material (carbon) due to the solidification of pumped media on the face outside diameter causing breakage upon start up. Severe cavitation could also cause this problem.

***Example of chipping on outside diameter of seal face***

*Replace seals and provide a flush to the seal area and/or eliminate any pump cavitation problems (see 3.1.4).*

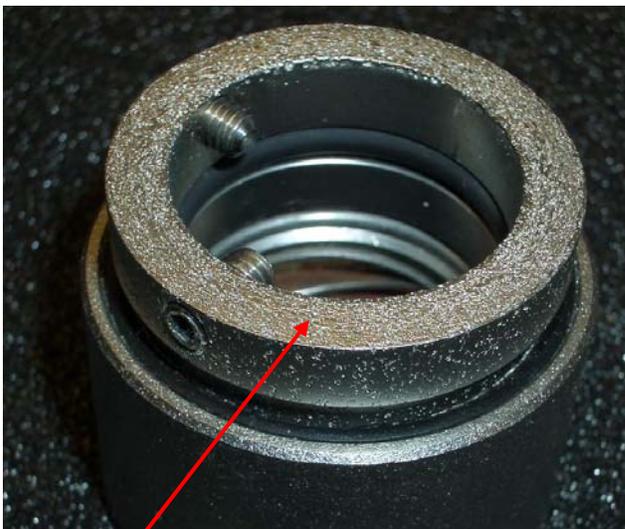
Mechanical seals are selected for particular applications and should not be subject to these problems. However severe corrosion can occur if used on incompatible pumped media. Also this can occur when a poor grade of carbon is being used, or when retrofitted by someone other than the original manufacturer - here gases are trapped within the material which vaporise during operation, thereby allowing solidification of pumped media on the seal faces giving shearing and tearing effects.

***Example of pitting corrosion on stainless steel***

***Example of crevice corrosion on a stainless steel face***

*Replace seals with faces that are compatible with pumped media and/or an improved carbon grade. Corrosive attack of carbon can be eliminated by selecting carbons which are relatively binder free upon seal manufacturer's advice.*

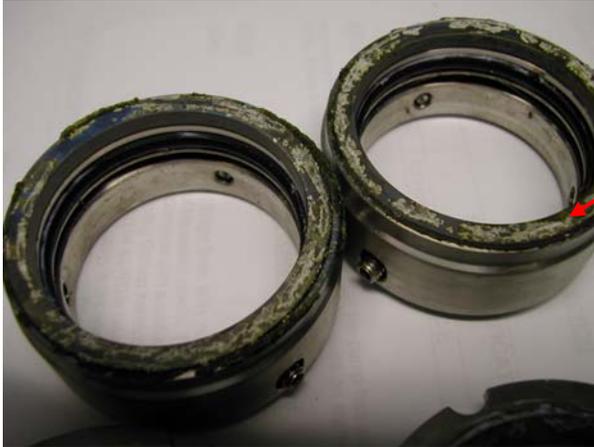
***An example of seal faces being subject to chemical attack***

***An example of mechanical seal failure whereby the pumped media has been allowed to solidify on the seal faces causing leakage.***

***Fitting a flushed mechanical seal arrangement will alleviate this problem.***

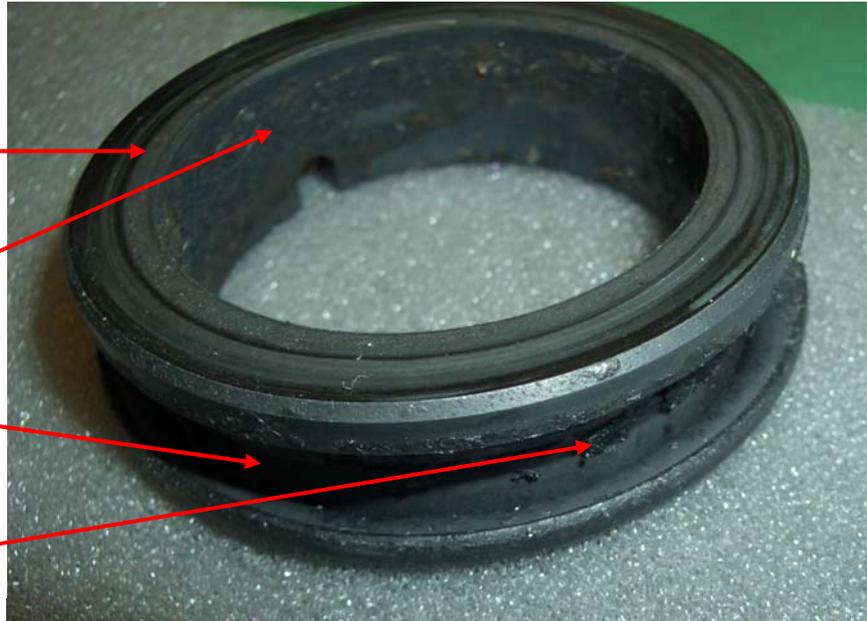
**Burnt debris found on the inner diameter**

**'O' ring is deformed (being axially moved from the fitted position close to the shaft step)**

**Burnt 'o' ring residues on the outer diameter**

If any discoloration of the seal parts is observed, then high friction between the seal faces has been created. Further evidence in 'O' ring hardening and 'setting' may support this. The seal faces will also show signs of excessive wear and possible heat distress in the form of thermal cracking.

The most probable causes are dry running, flashing, or very poor face lubrication. Flashing being 'boiling of the fluid film' on the seal faces. Other causes could be incorrect fitting of the seal causing high friction and thereby high temperatures within the seal or the pump is operating at excessive pressures or speed.

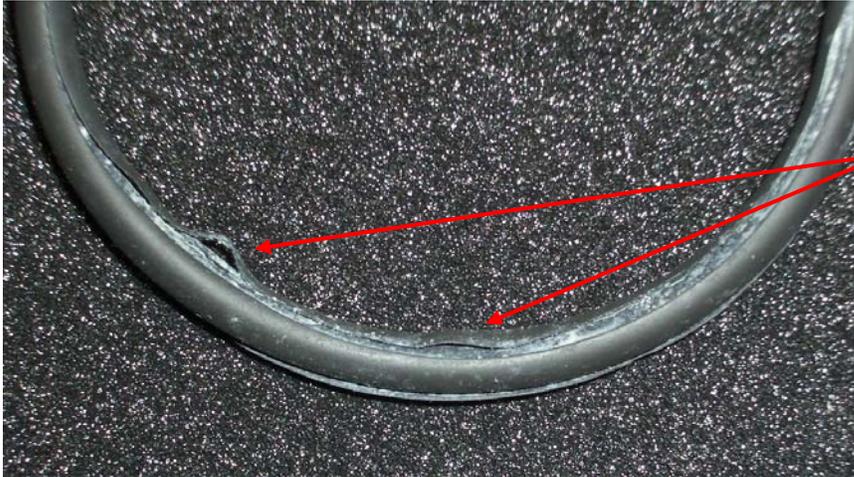
This is caused by excessively high pressure and/or the size of the seal 'O' ring groove being incorrect. As the 'o' ring extrudes it will tear in the gap between shaft and seal ring.

**Example of 'O' ring damaged by excessive pressure**

*Replace elastomer and reduce system pressures. Also check that the 'O' ring groove size is correct by referring to seal manufacturer.*

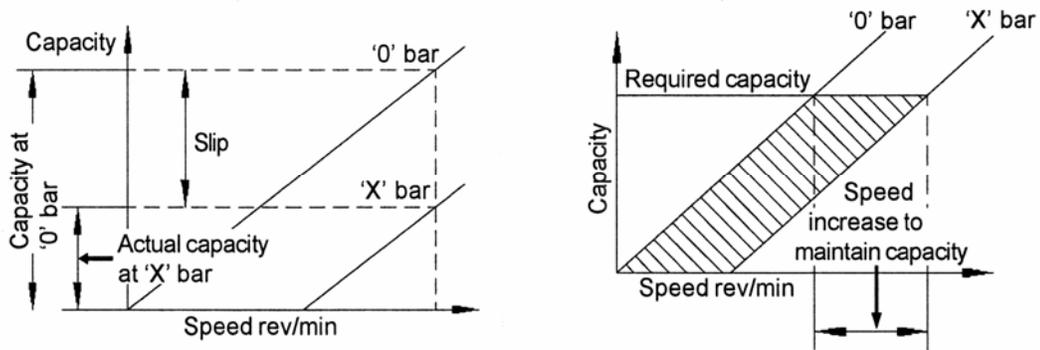
The amount of slip will increase as pressure increases which is shown below. For a given pump speed the amount of slip can be seen as the capacity at 'zero' bar less the capacity at 'X' bar. To overcome this amount of slip it will be necessary to increase the pump speed to maintain the capacity required.

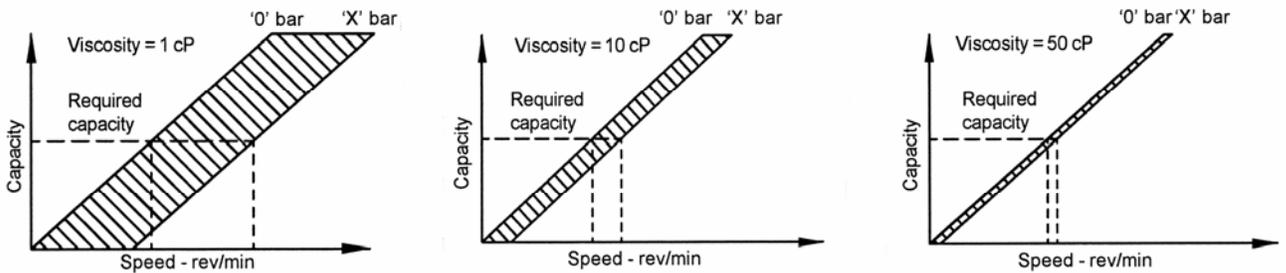
The amount of slip will decrease as fluid viscosity increases. The effect of viscosity on slip is shown below. The pressure lines will continue to move towards the 'zero' pressure line as the viscosity increases.

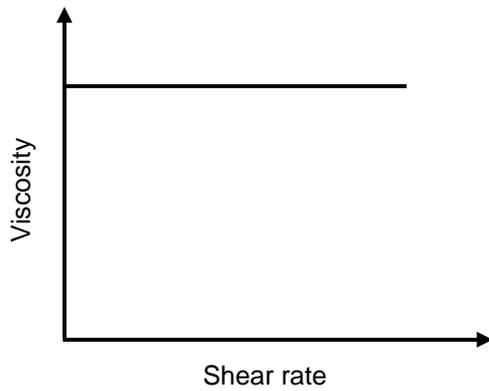
Poor pump performance may be attributed to an unexpected change in fluid viscosity. In some fluids the viscosity is constant regardless of the shear forces applied to the layers of fluid. These fluids are known as Newtonian fluids whereby at a constant temperature the viscosity is constant with change in shear rate or agitation.

### Newtonian Fluid Behaviour

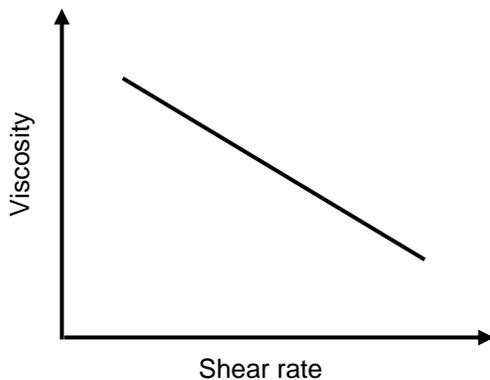
### Psuedoplastic Fluid Behaviour

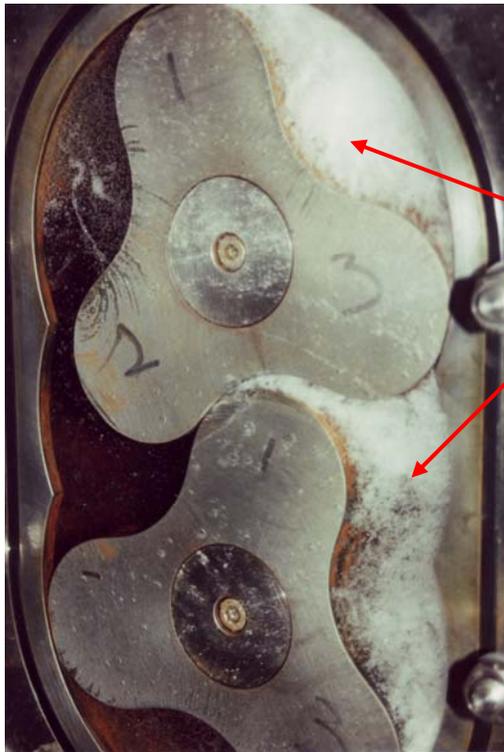
**Tri-lobe Rotor Pump**

The term cavitation is derived from the word cavity, meaning a hollow space. In pump terminology, cavitation is an undesirable vacuous space in the inlet port of the pump normally occupied by fluid. The lowest pressure point in a pump occurs at the pump inlet - due to local pressure reduction part if the fluid may evaporate generating small vapour bubbles known as 'vacuoles'. These vacuoles are carried along by the fluid and implode instantly when they get into areas of higher pressure.

*Examples of  
small vapour  
bubbles*

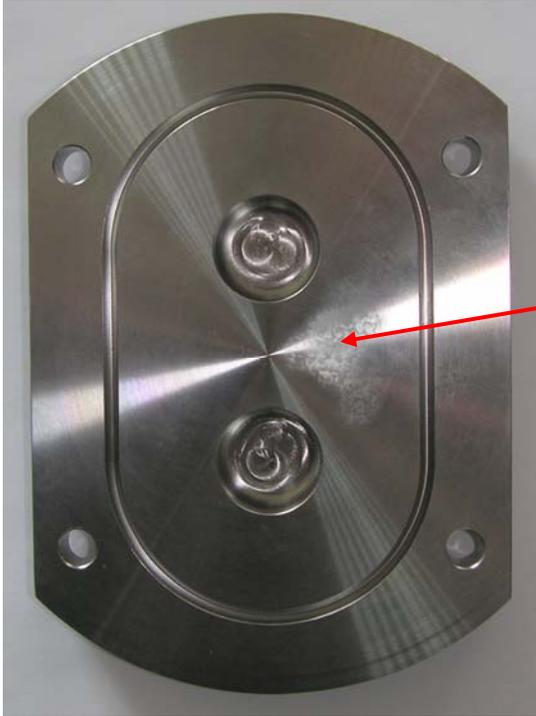
**Typical cavitation effect on pump rotorcase cover.**

**Severe cavitation will be evident even after a short operating period. Blemishes will appear on the rotorcase cover on the discharge side of the pump where vacuoles implode in the high pressure region.**

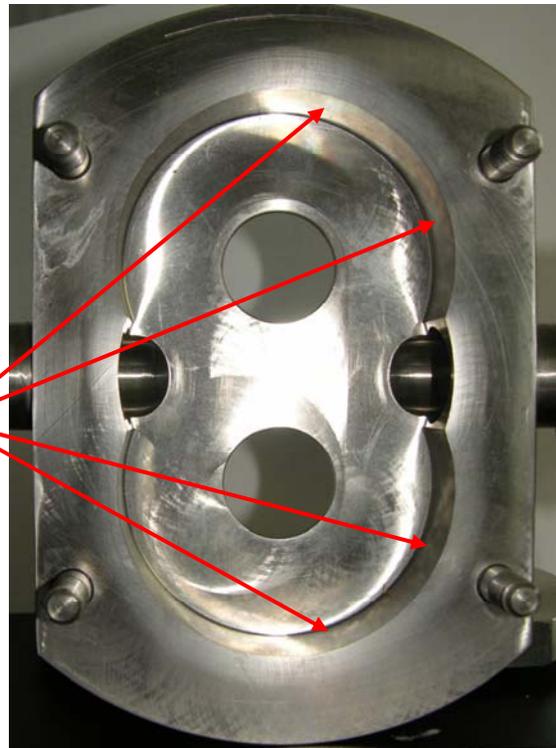
**Cavitation can cause damage within the rotorcase as a consequence of shock loading the shafts. In extreme cases this can result in the rotor tips making contact with the casing as well as material erosion from imploding**

**Contact areas**

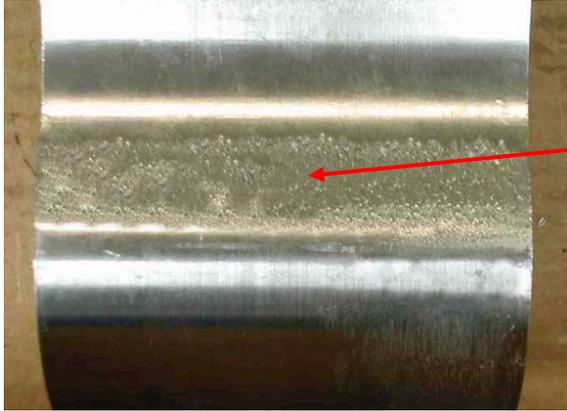
**Cavitation effect on pump rotor may result in rotor to rotor contact.**

**Rotor flank showing effect of typical cavitation damage where minute particles of the rotor material are eroded by implosions of vacuoles**

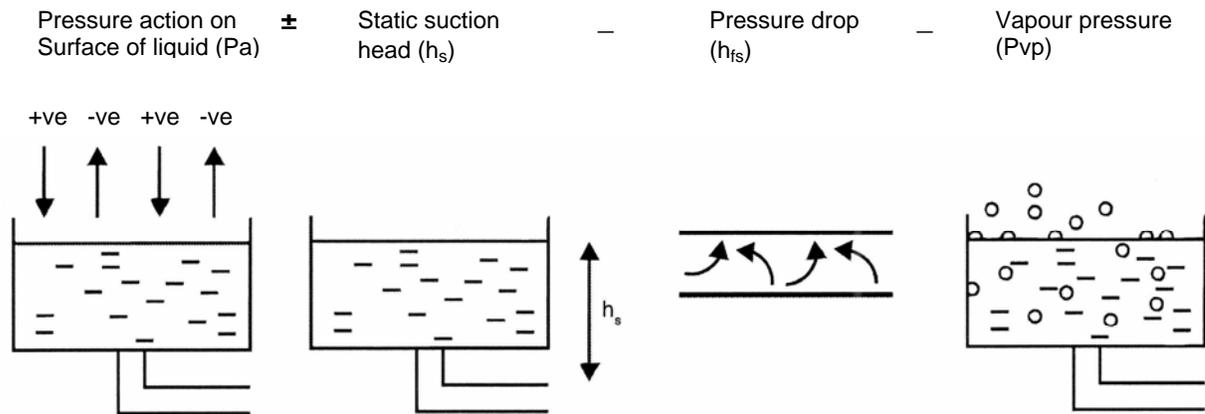
### NPSHa (metres) =

- Pa = Pressure absolute above fluid level (bar)
- $h_s$  = Static suction head (m)
- $h_{fs}$  = Pressure drop in suction line (m)
- Pvp = Vapour pressure (bar a)

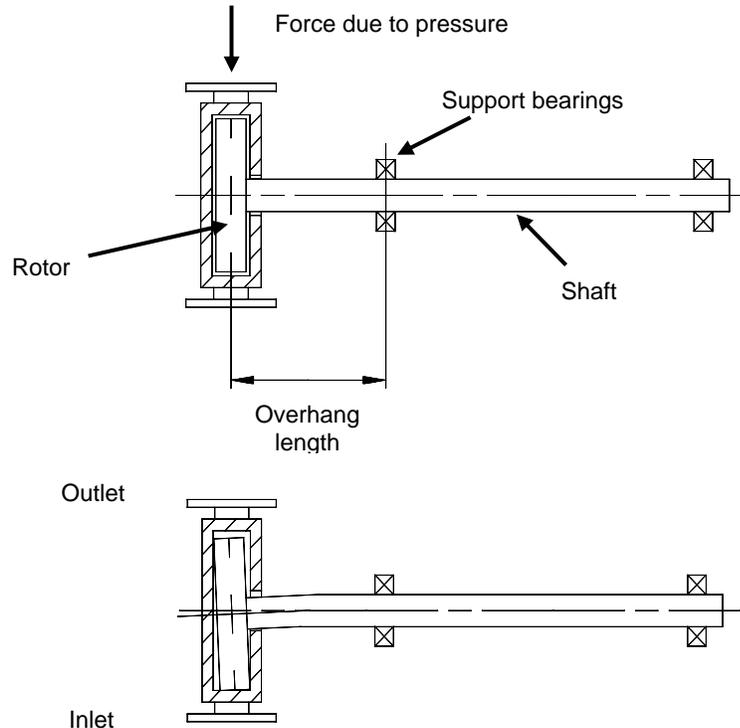
The design concept of the rotary lobe pump is to have no contacting parts in the pumphead. This requires having the shaft support bearings to be mounted outside of the pumphead, which results in an overhung load, caused by the rotors fitted to the shafts as shown below.

The effect of pressure on the rotors will cause shaft deflection, which could result in contact between rotors, rotorcase and rotorcase cover. To allow for this pressure effect, clearances are built into the pumphead between surfaces that may contact. For the Series S, X and D pump ranges there is only one pressure rating, which is the maximum differential pressure of the particular pump model. However, the Series A and G pump ranges have more than one pressure rating.

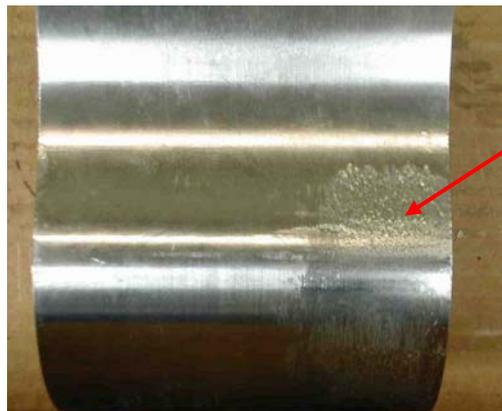
Should the pressure rating be exceeded it is likely that as product wetted parts of the Series S, X and A pump ranges are predominantly manufactured from stainless steel any contact between rotating and stationary parts would cause 'galling' and possible pump seizure.

*Example of rotor galling*

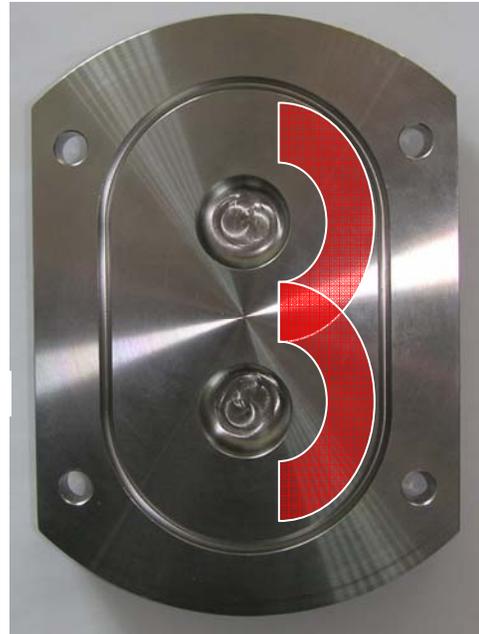
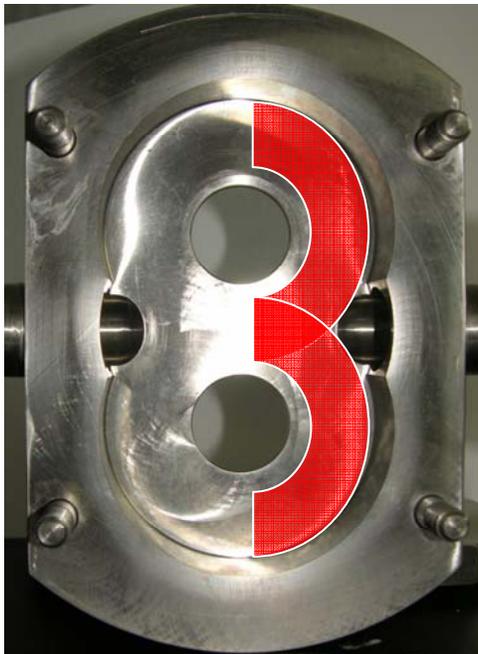
***Rotor tip contact will be initially visible on the suction side of the rotorcase rear face.***

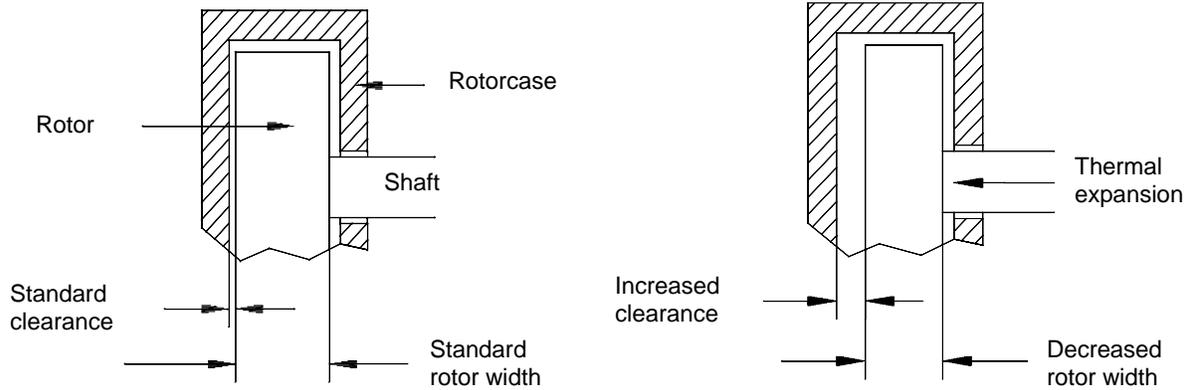
Changes in temperature will cause expansion upon heating or contraction upon cooling, to the pump rotorcase and gearcase components. The most significant result is the movement between shaft and gearcase/rotorcase allowing the rotors to move forward or backward in the rotorcase. With the rotors being allowed to move forward there will be a reduction to the front clearance. To compensate for this, the Series S, A, G and D pump ranges have increased clearances as shown below.

***The clearance is exaggerated to show the temperature***

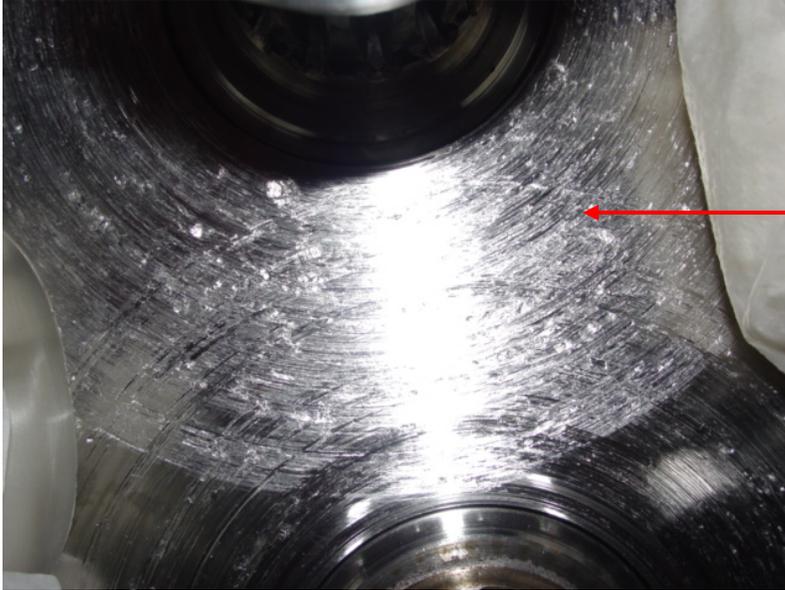
***Rotorcase with marks attributed to thermal shock. Here the shafts have contracted at a faster rate than the rotorcase, thereby causing contact with rear casing face.***

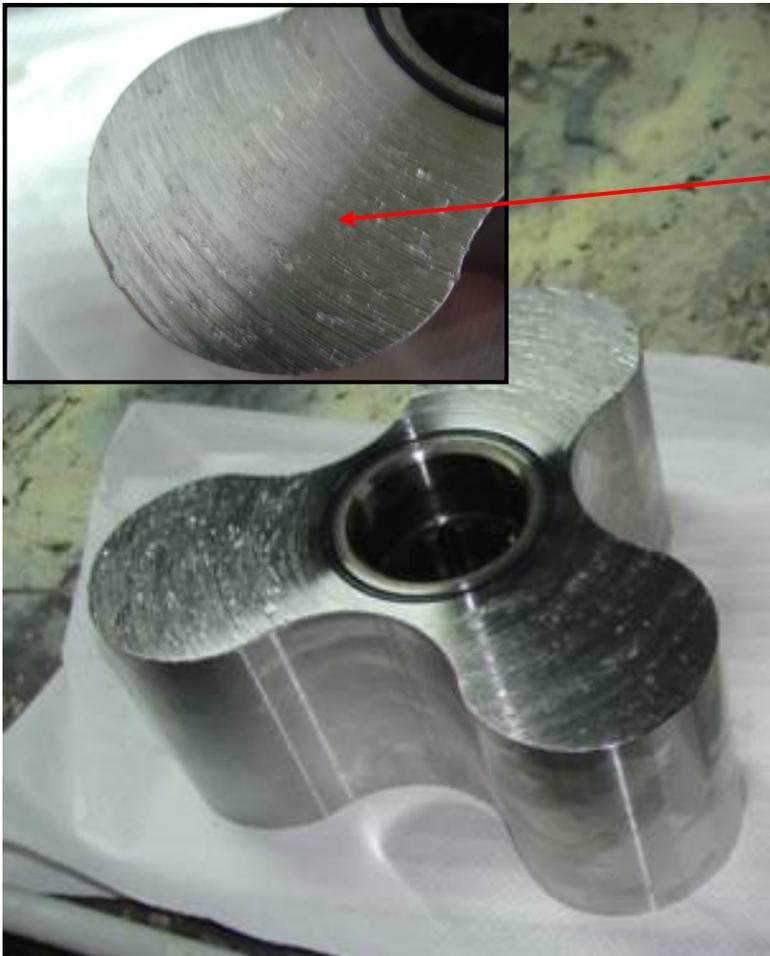
***Rear rotor face with signs of rotorcase contact, indicative of rapidly decreasing temperature i.e. thermal shock - hot to cold.***

***Cold to hot shock would cause rotors to contact rotorcase cover.***

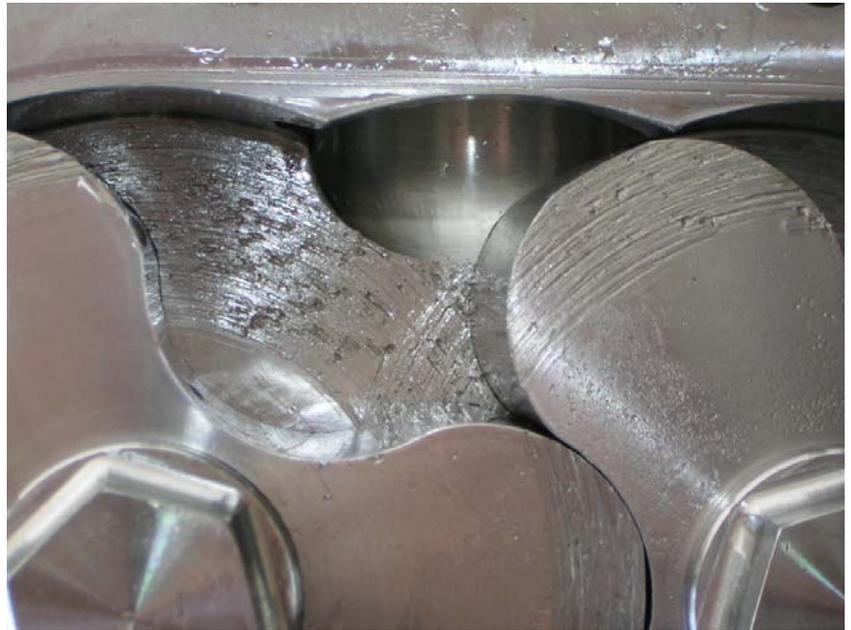
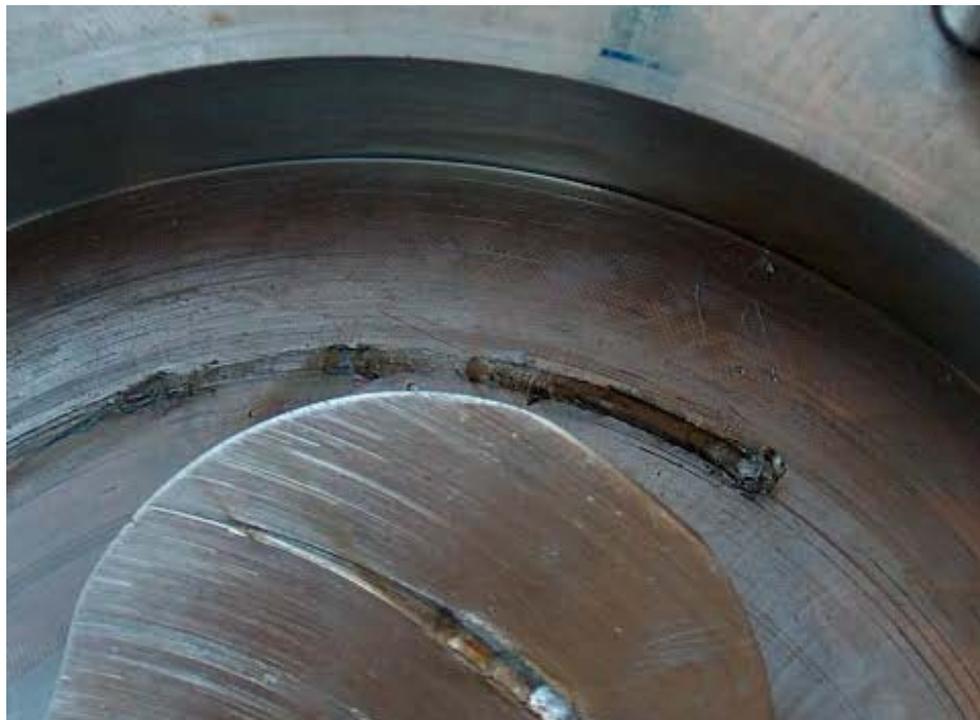
*Examples of 'galling' caused by initial hard solid passing through pump*

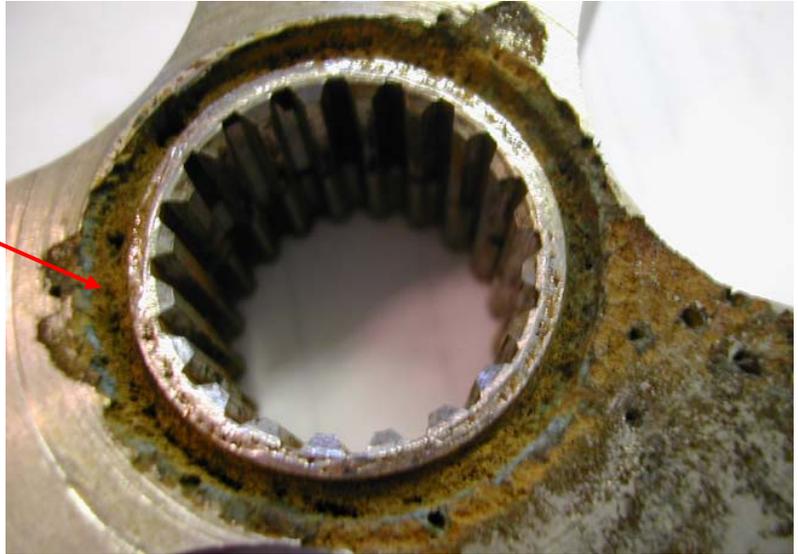
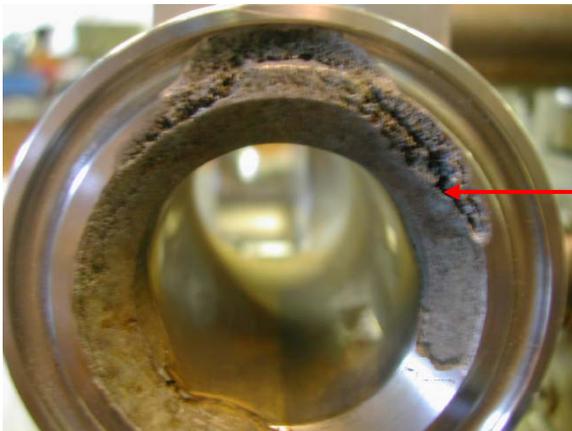
*Example of corrosion on pump rotor.*

*Example of corrosion on pump rotorcase port.*

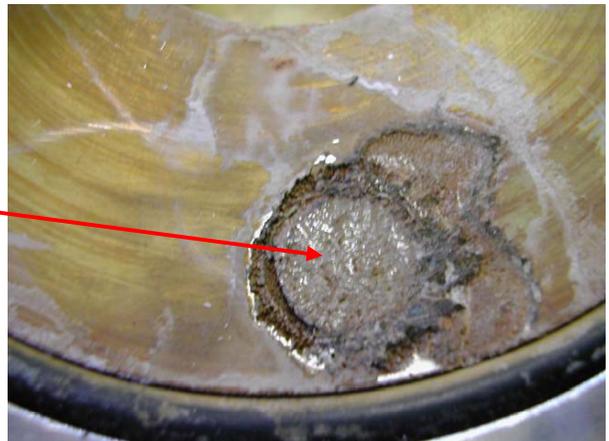
*Example of corrosion on pump rotorcase cover.*

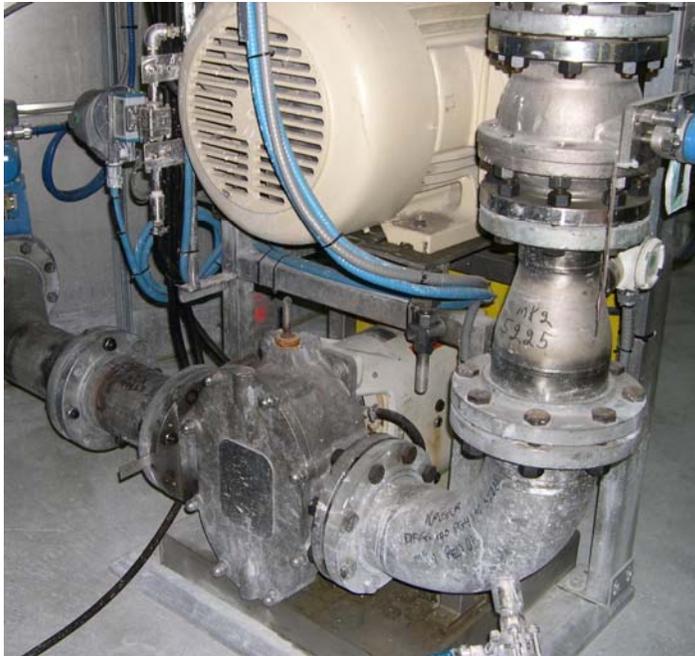
*Example of a poor installation showing a short radius bend fitted directly on to the pump discharge connection.*

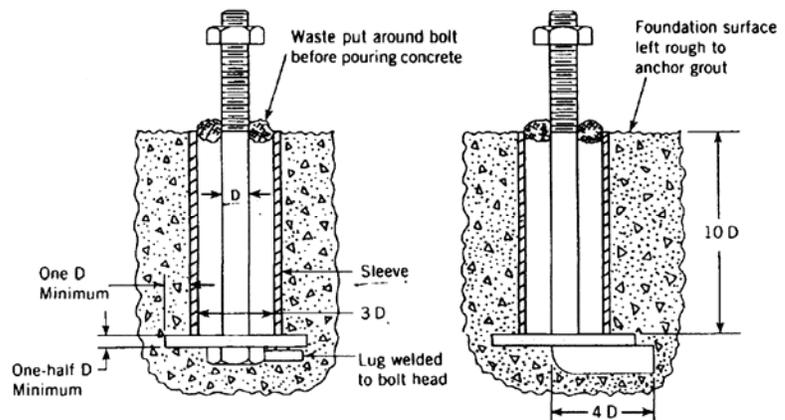
The foundation should be approx. 150 mm longer and wider than the baseplate. The depth of the foundation should be proportional to the size of the complete pump unit. For example, a large pump unit foundation depth should be at least 20 times the diameter of the foundation bolts.

D = Diameter of foundation bolts

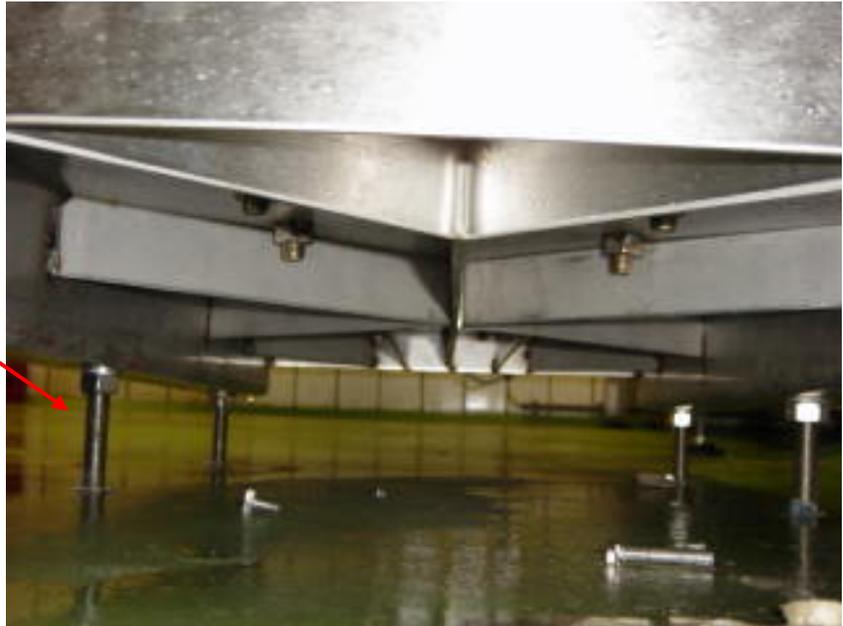
**Example of poor installation where underside of base shows bolts only free standing on the floor.**
